TEST REPORT

Report No. : BJ-R231115105A-EN

Test Item : IP67 Test、Drop Test

Sample Name	Mobile Computer
Sample Model	ME61
Sample No.	BJ-R231115105A-1#~2#
Sample Size	/
Weight Of Sample	/
Sample Quantity	2 PCS
Manufacturer	Meferi Technologies Co., Ltd.
Address	4501, 45th Floor, Building A, No. 530, Middle Tianfu Avenue, High-tech Zone, Chengdu, China
Sample Source	Commissioned units send sample
Inspection Type	Commissioning test
Sample Description	Sample appearance is good

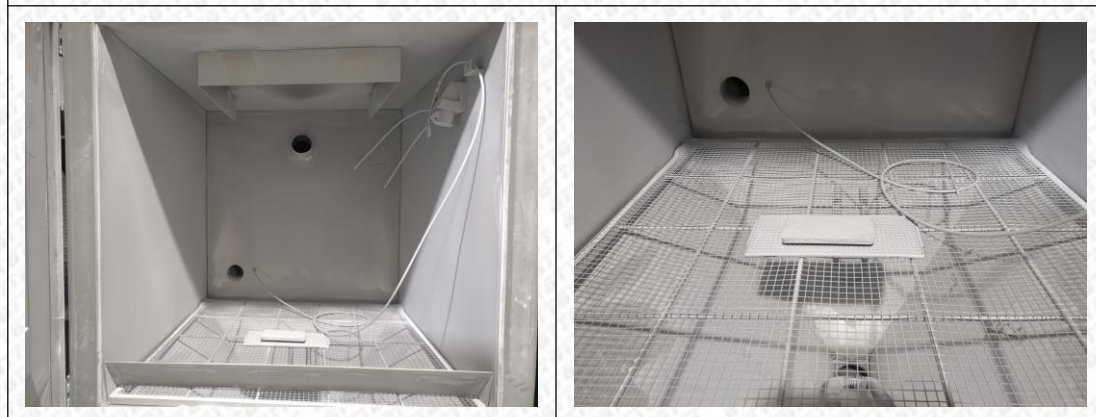
IP6X

The amount of talc powder in the test box is per cubic meter metric
test box volume 2 kg, talc powder filtered by metal square sieve,
wire diameter 50 μm , sieve hole size is 75 μm , test for 8 hours.

Test setup

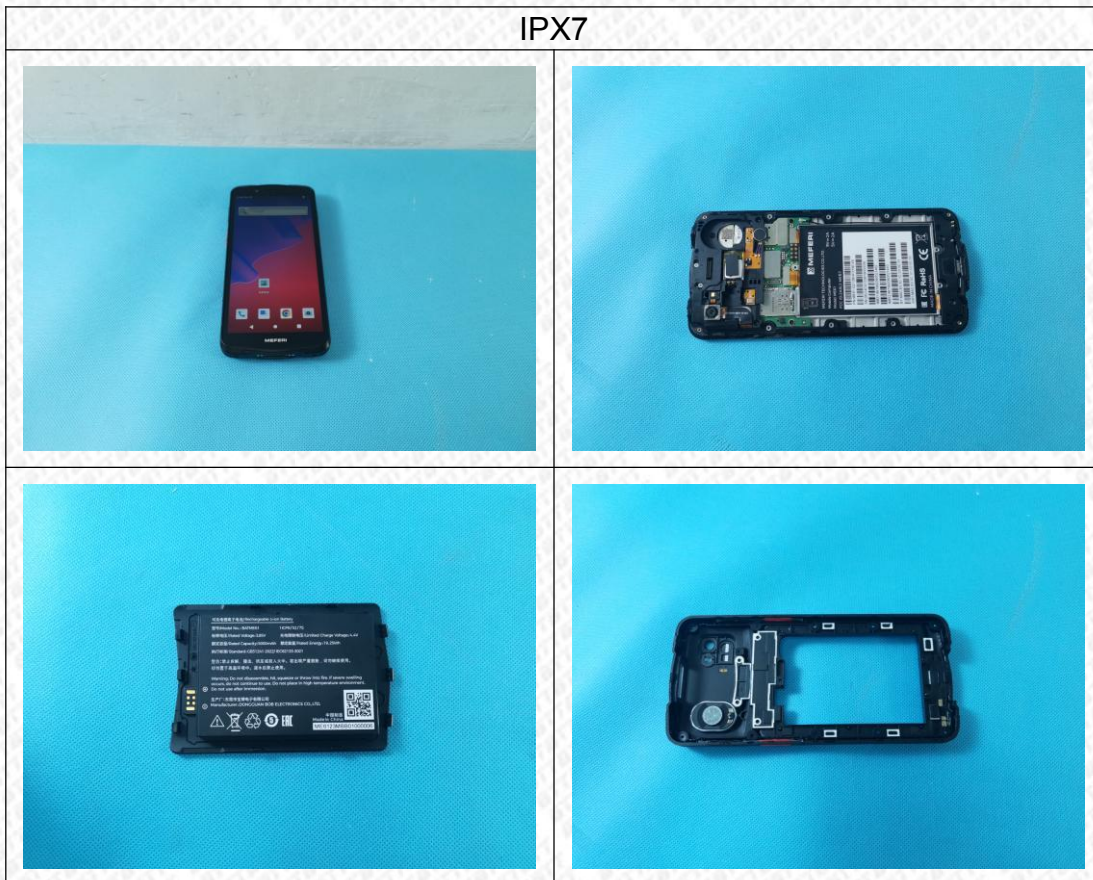
IPX7

Test Items	Sample No.	Test Results
IP67 Test	1#	After test, there was no water and no dust enter the enclosure of the sample, and the function was normal.
Drop Test	2#	After test, the sample showed no obvious mechanical damage, and the function was normal.

After test
